XXII. *Proceedings relative to the Accident by Lightning at Heckingham.*

Report of the Committee.

PURSUANT to your resolution, appointing us a committee to examine the House of Industry at Heckingham in Norfolk, which had been struck by lightning although it was armed with conductors, we arrived there on the 21st of January. Seven months had then elapsed since the accident, yet we had the satisfaction to learn, that no material changes had been made in the conductors or the building in that period; some laths that had been burnt, some bricks and pantiles which had been damaged or thrown down, were replaced; but we found means to procure distinct information of those repairs from the workmen who had been employed to execute them. In order to communicate a clear idea of the accident, it will be necessary to premise a general account of the building; then to represent the manner in which the conductors were applied; and, lastly, to describe the stroke of lightning, with its effects.

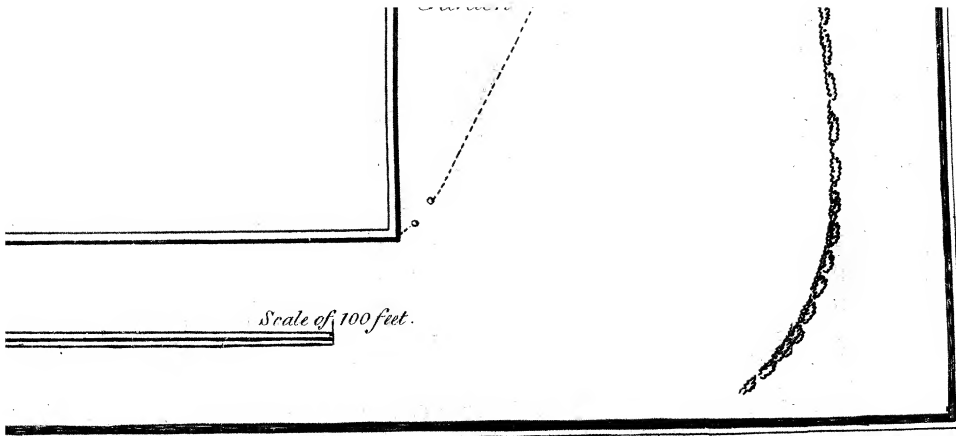
Fig. II.

As both extremities of the hip, therefore, were, in some degree at least, affected by the lightning, we proceeded to ascertain their distances from the nearest conductor, which was that affixed to the chimney E (fig. 2. and 4.). Having determined the necessary measures, and calculated the hypotenuse, the distance from the point of the conductor to the beginning of the lead on the top of the hip (*e*, fig. 4.) came out 42 feet and a quarter; thence to the bend where we found the marks of fusion (from *e* to *f*, fig. 4.) was five or six inches more; and as the hip measured about 27 feet in length, the distance from the conductor to the bottom of the hip (*g*, fig. 4.) may be called 69 feet. From the top or bottom of the hip, to the nearest part of the conductor as it ran downward, the distances were not a foot less than these measures. We then took down the uppermost rod of the conductor, and carefully examined it, especially at the point, and at the hook and screws by which it had been joined to the second rod; but could nowhere discover the least mark of fusion or other injury. At the bottom of this conductor, however, where, having joined that from the chimney

*SOUTH WEST VIEW of the EAST WING and
shewing the junction of the two Conductors that*
